REPORT OF  
INVESTIGATION & DEVELOPMENT  
OF  
PRELIMINARY COSTS TO REHABILITATE  
WORSHAM STREET BRIDGE

FOR  
CITY OF DANVILLE, VIRGINIA  
DEPARTMENT OF PUBLIC WORKS

AUGUST 2, 2004

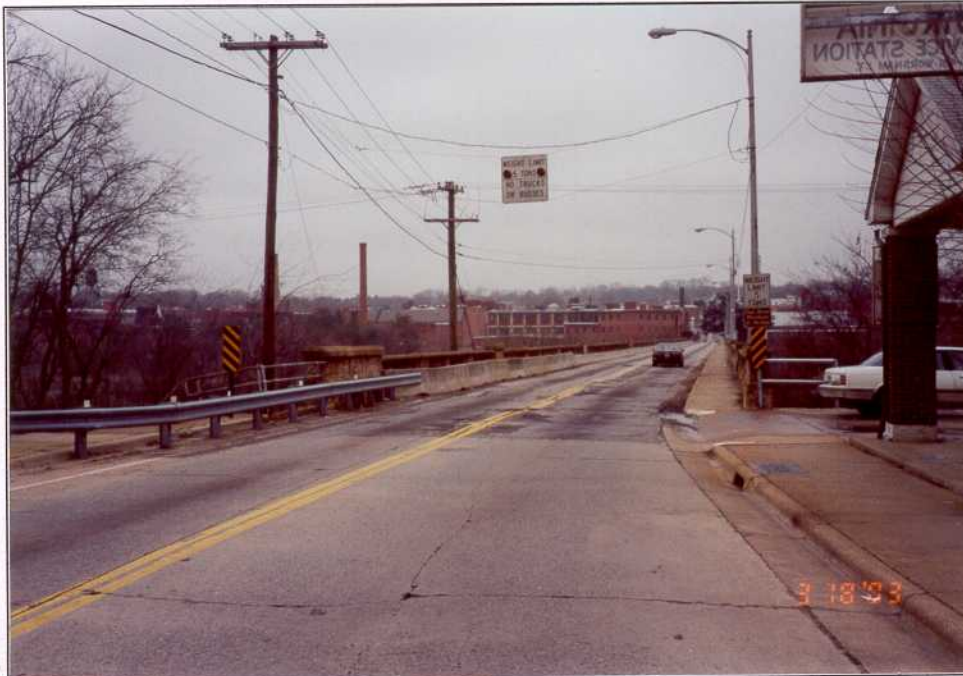
K754-10

**APPROACH ELEVATION LOOKING SOUTH. NOTE OBJECT MARKERS (TYPE 3) AND POSTED WEIGHT LIMIT SIGN.**

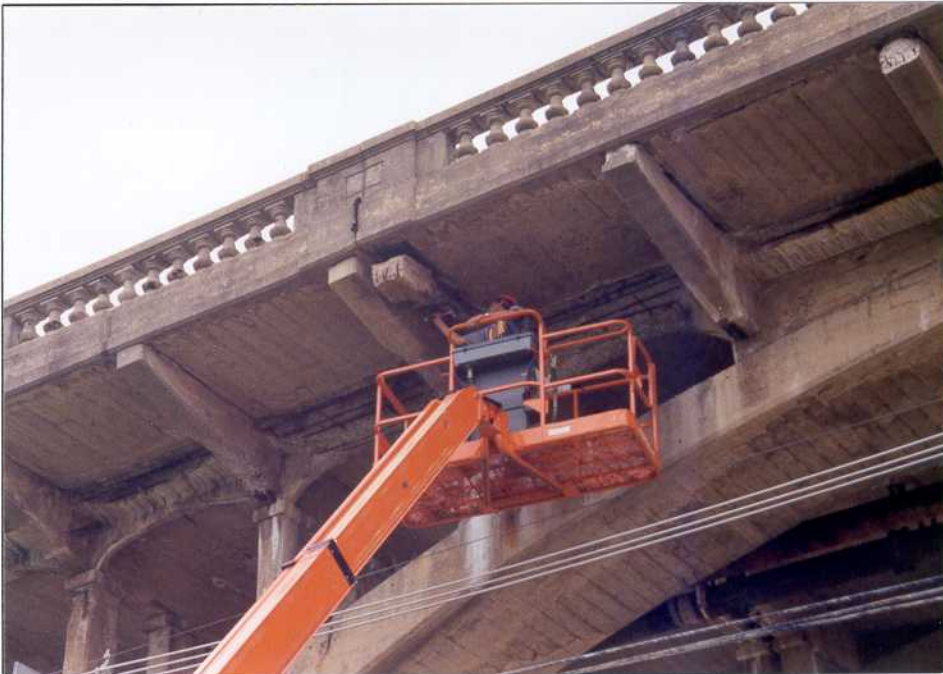
**C220-3**

**UPSTREAM SIDE OVER PED. TRAIL - NOTE CONT. REMOVING LOOSE CONC. WITH MASONRY HAMMER AT FLOORBEAM CANTILEVER THAT HAS SAGGED AWAY FROM THE SIDEWALK.**

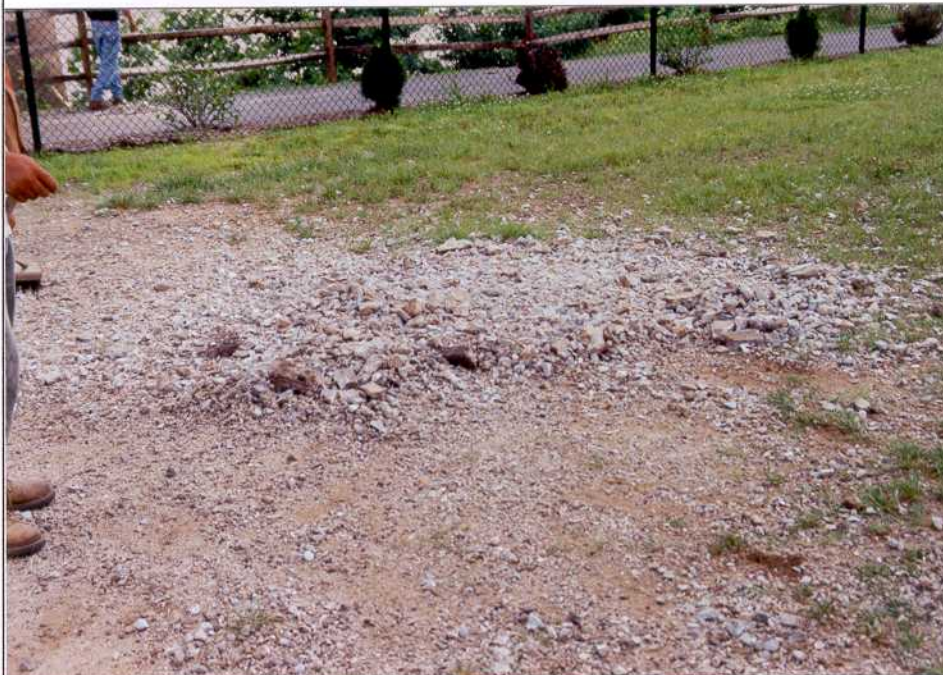
**C220-5**

**UPSTREAM, SPAN D - NOTE PILE OF CONCRETE DEBRIS CONTRACTOR CHIPPED OFF.**

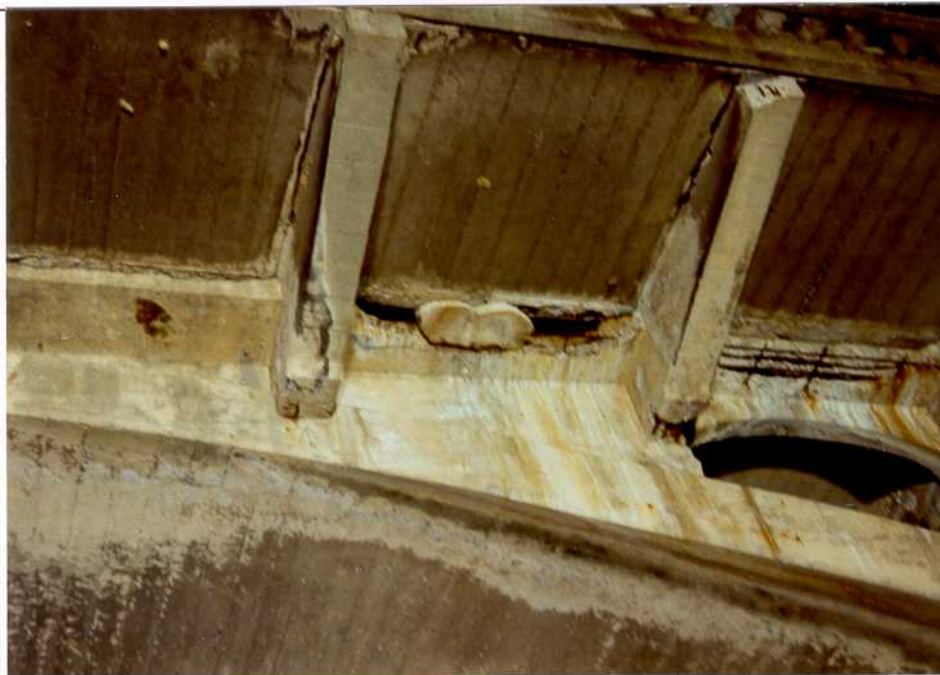
C220-12

UPSTREAM SIDE OVER EBL ROUTE 58 - NOTE HOLE ALONG CURBLINE.

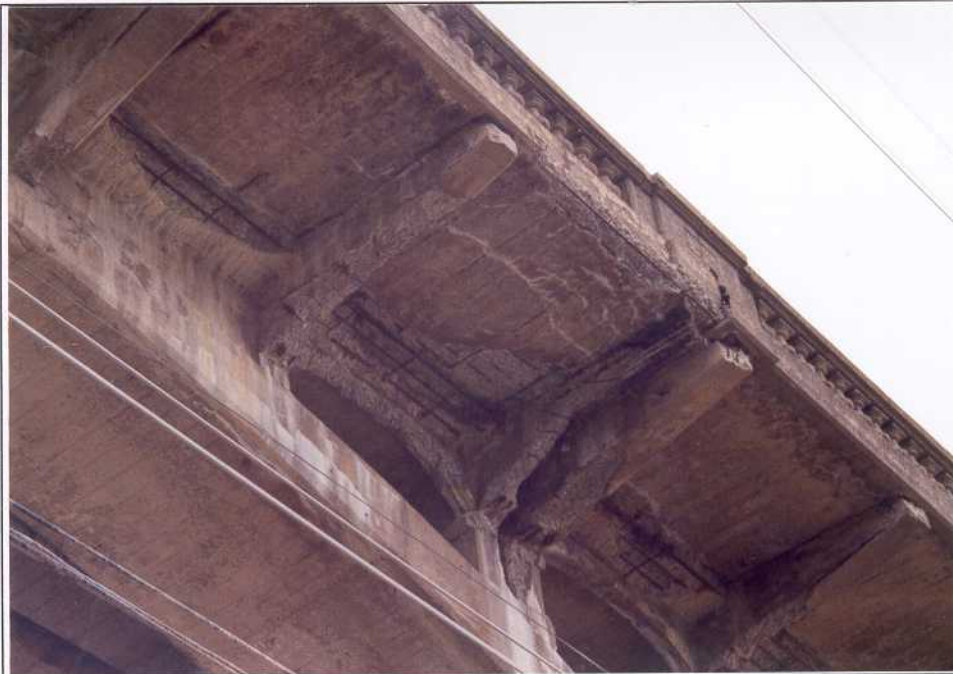
**C220-6**

**UPSTREAM, SPAN D - NOTE SIDEWALK SUPPORT ALMOST  
READY TO FALL OFF.**

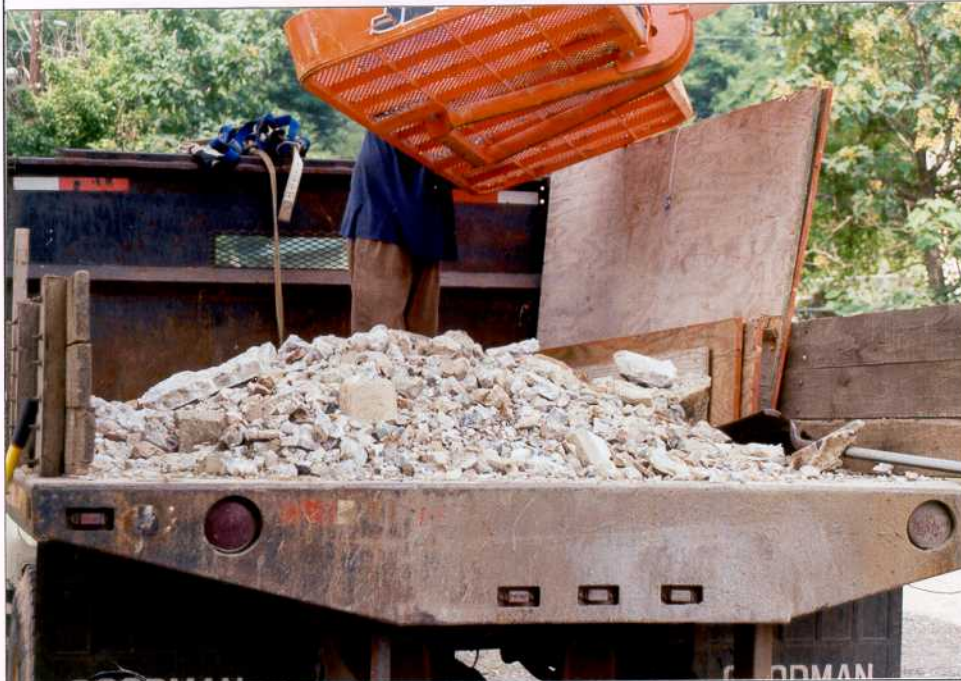
**A106-13**

**APPROXIMATELY 20% OF CONCRETE REMOVED JUNE 28 -  
JULY 2, 2004.**

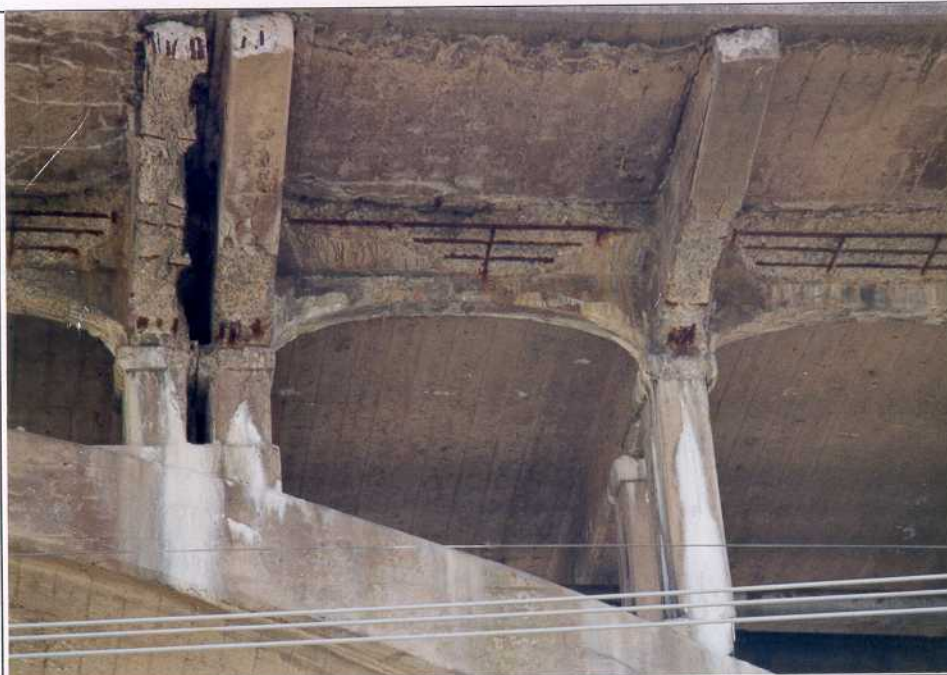
A105-1

**SPALLED AND DELAMINATED CONCRETE AND CORRODED  
REBAR IN DECK, FLOORBEAM, COLUMN J AND UPSTREAM ARCH  
APPROXIMATELY 20' SOUTH OF CROWN, SPAN D.**

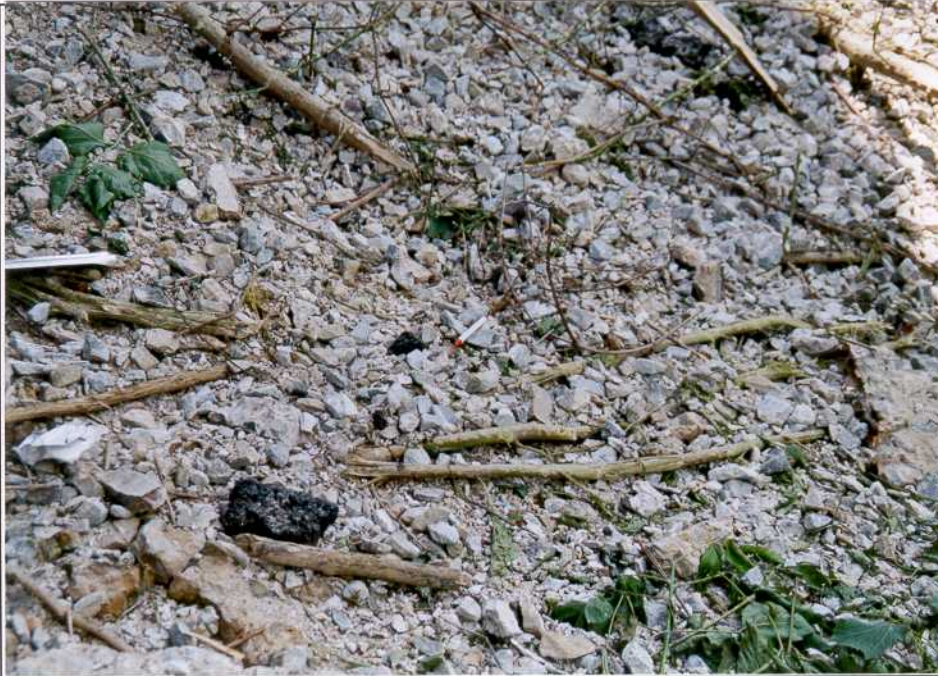
**A105-13**

In June 2004, a contractor's crew was working on repairs to the sidewalk when a section the full width of sidewalk and several feet long fell out to the ground leaving only the reinforcing bars in place. Inspection of other areas of sidewalk revealed a number of other areas that were in similar condition to the one that collapsed.

**AREA OF CONCRETE SIDEWALK, SPAN H, THAT FELL WHILE BEING REPAIRED. NOTE ABSENCE OF MORTAR BONDING TO CONC. AGGREGATE INDICATING POOR QUALITY CONCRETE.**

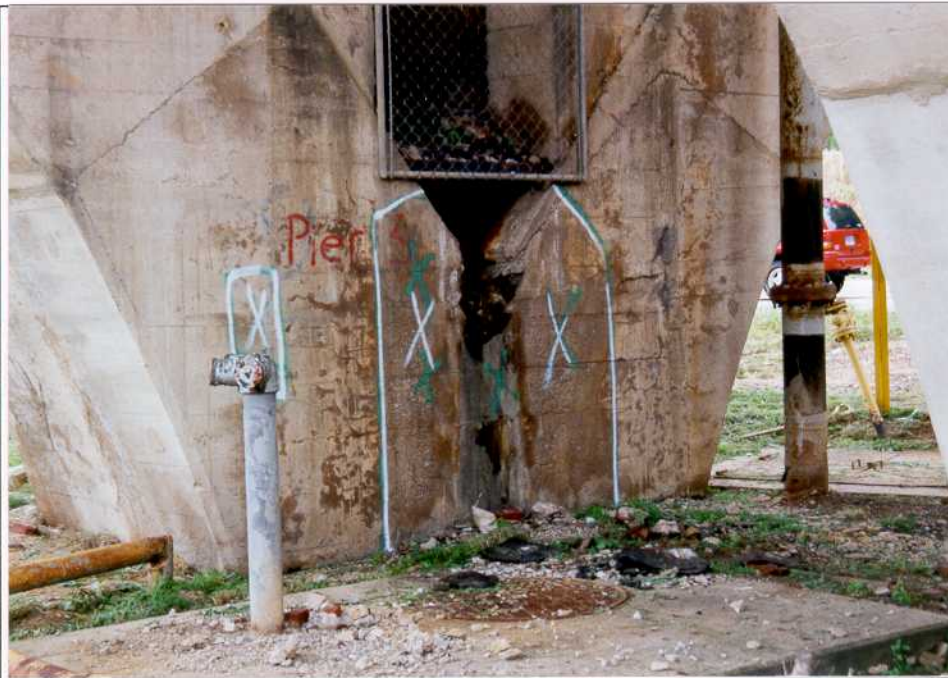
C215-13

**PIER 3, UPSTREAM, INSIDE FACE OF ARCH - NOTE  
DELAMINATED CONCRETE AT GROUND LEVEL (TYPICAL) ON  
DOWNSTREAM SIDE.**

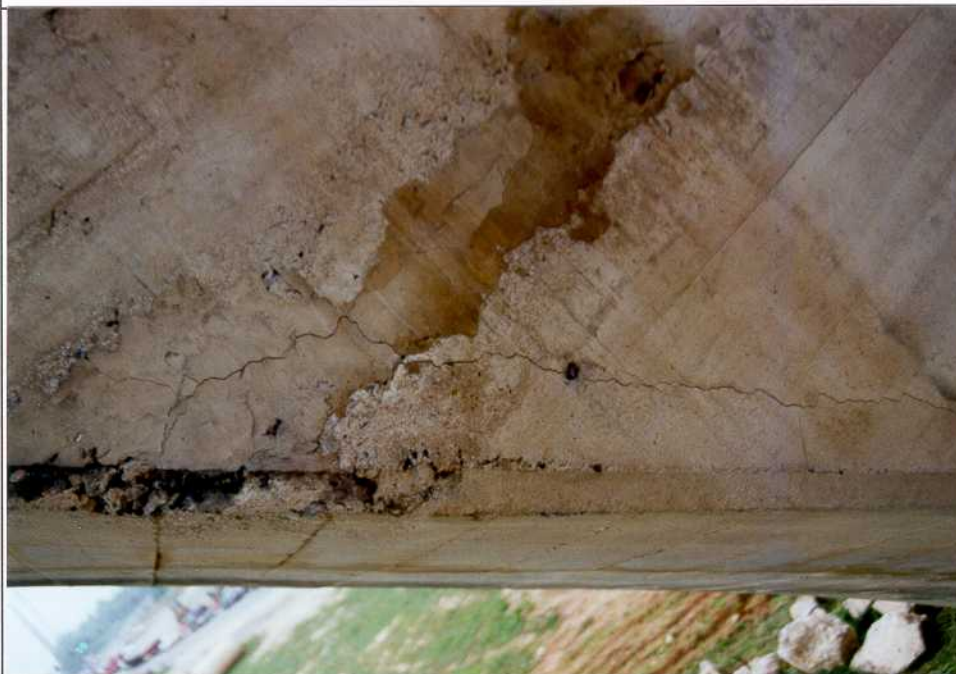
C216-4

**UPSTREAM ARCH, SPAN C - NOTE DELAMINATED CONCRETE  
ON INTERIOR SIDE.**

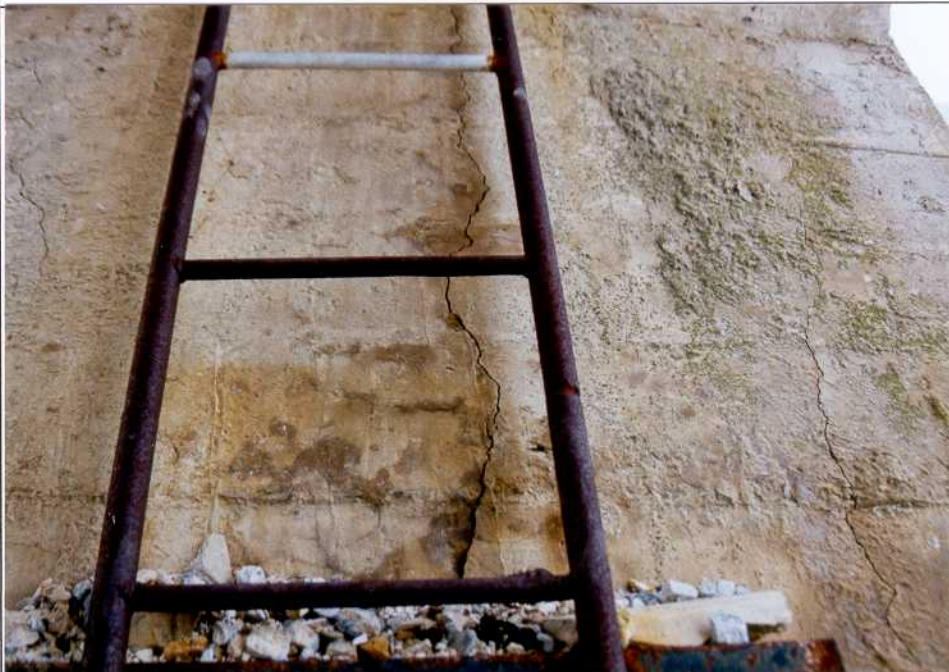
**C215-5**

**SPAN C, UPSTREAM ARCH - CRACK IN TOP OF ARCH APPROXIMATELY 20' FROM PIER 3.**

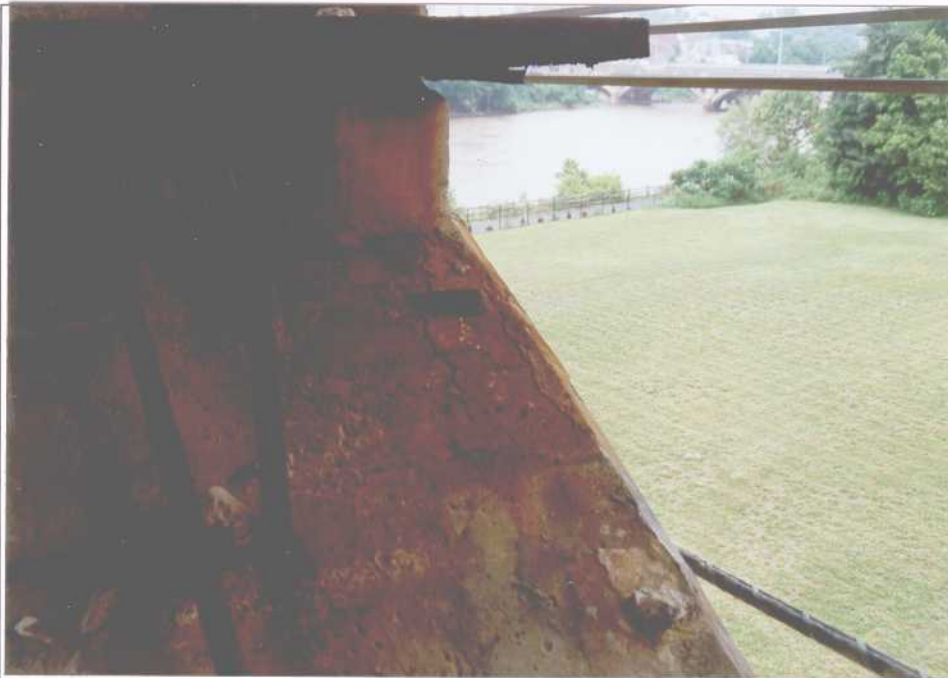
C215-6

**DELAMINATED CONCRETE, TOP OF ARCH, SPAN C, UPSTREAM SIDE, APPROXIMATELY 30' FROM PIER 3.**

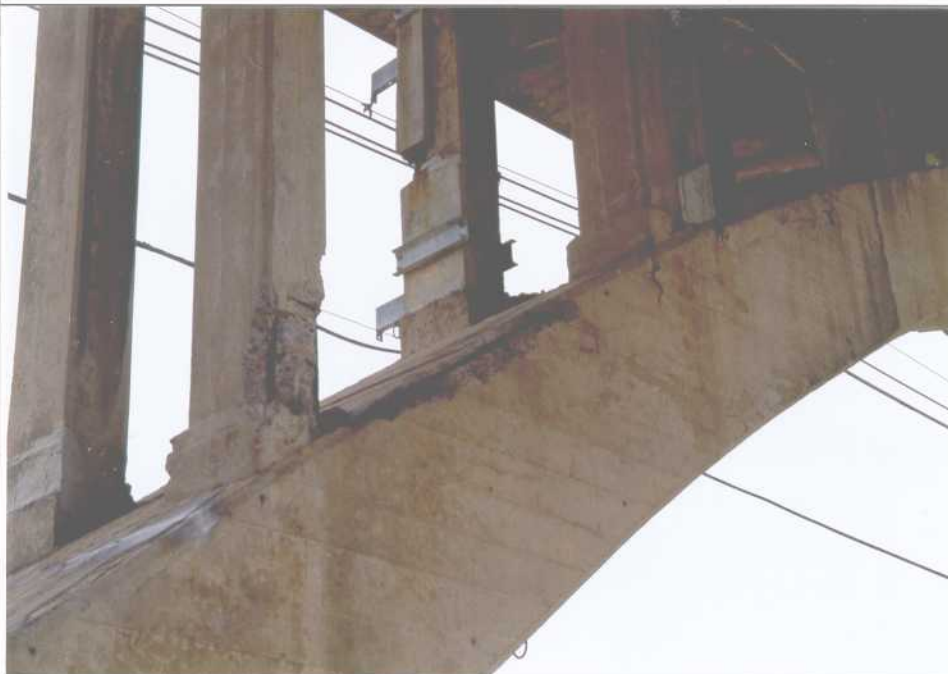
C215-17

**DETERIORATED CONCRETE ON TOP OF ARCH, SPAN C, UPSTREAM SIDE (APPROXIMATELY 20' FROM PIER 4).**

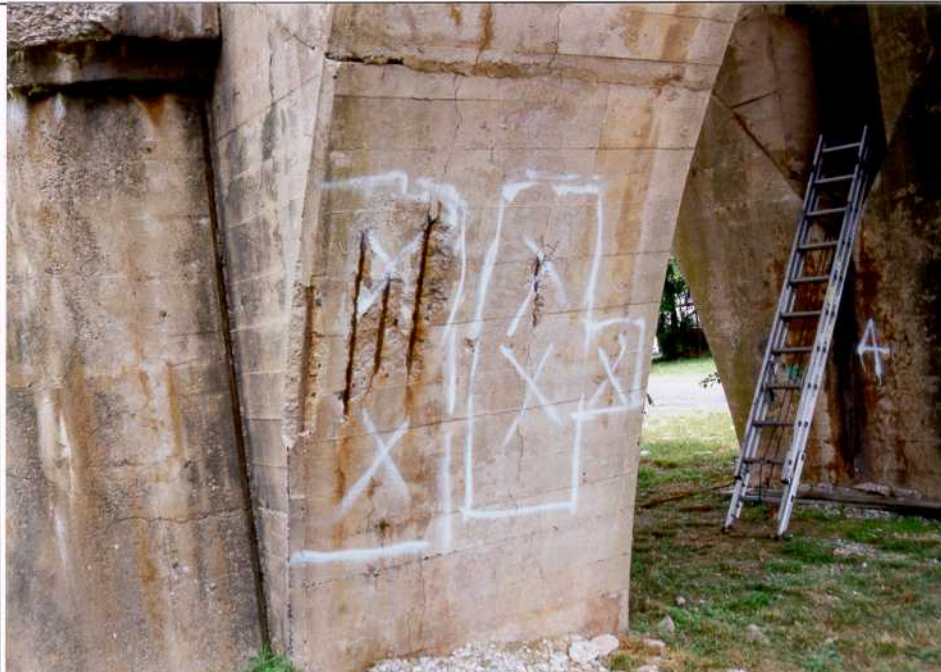
**C215-16**

**PIER 4, SPAN C, UPSTREAM SIDE - NOTE DETERIORATED  
CONCRETE WITH EXPOSED REINFORCING STEEL ON  
UNDERSIDE OF ARCH AT GROUND LINE.**

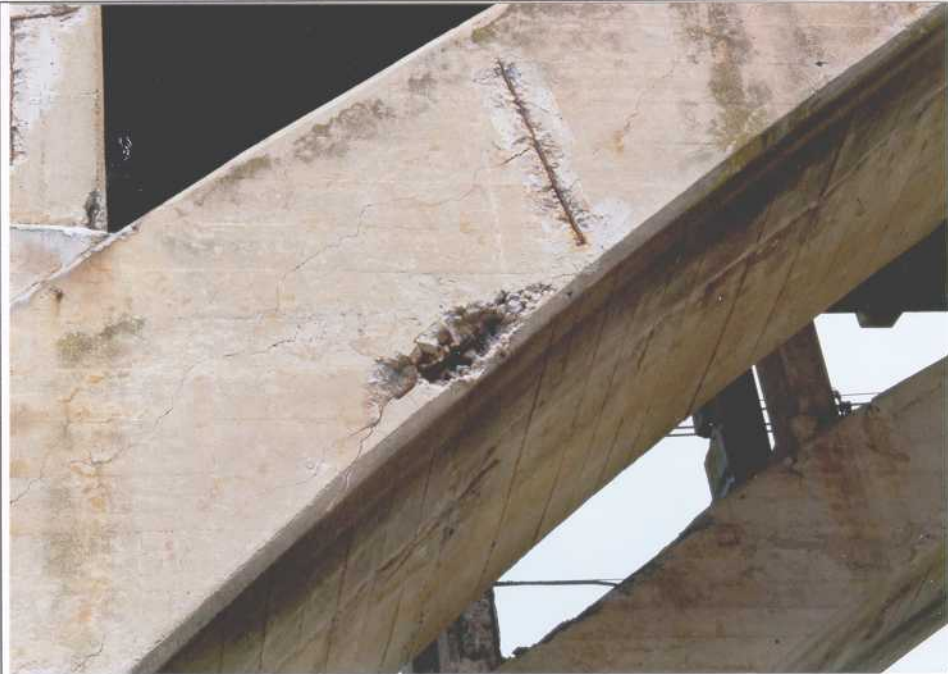
**C215-10**

**SPAN C, DOWNSTREAM SIDE, NEAR PIER 4 - NOTE  
DETERIORATED AND HONEYCOMBED CONCRETE ON SIDE OF  
ARCH.**

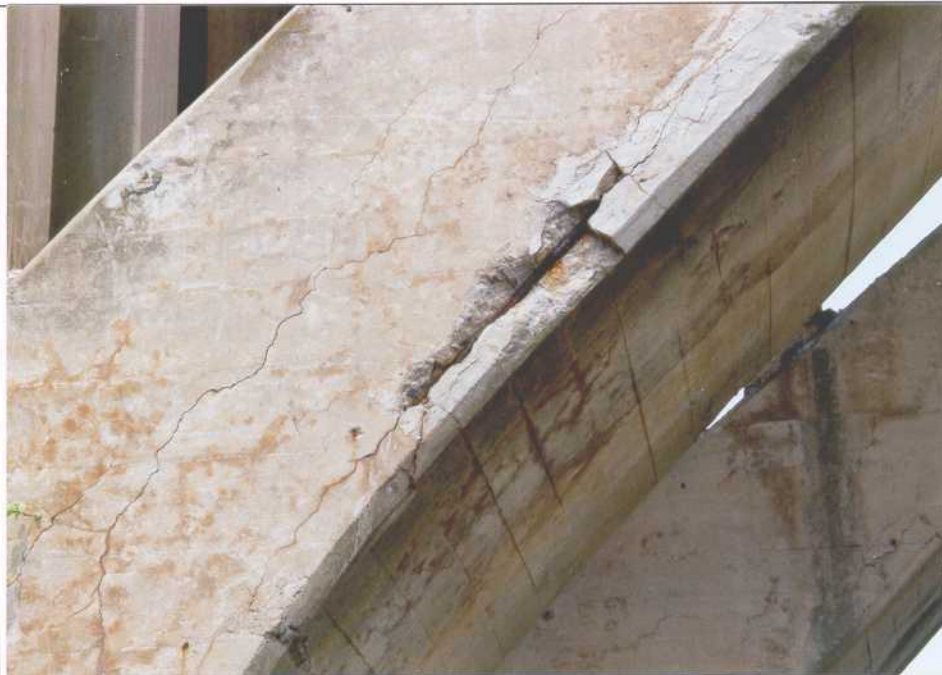
**C215-11**

**SPAN C, DOWNSTREAM SIDE, NEAR PIER 4 - NOTE  
DETERIORATED AND HONEYCOMBED CONCRETE ON SIDE OF  
ARCH.**

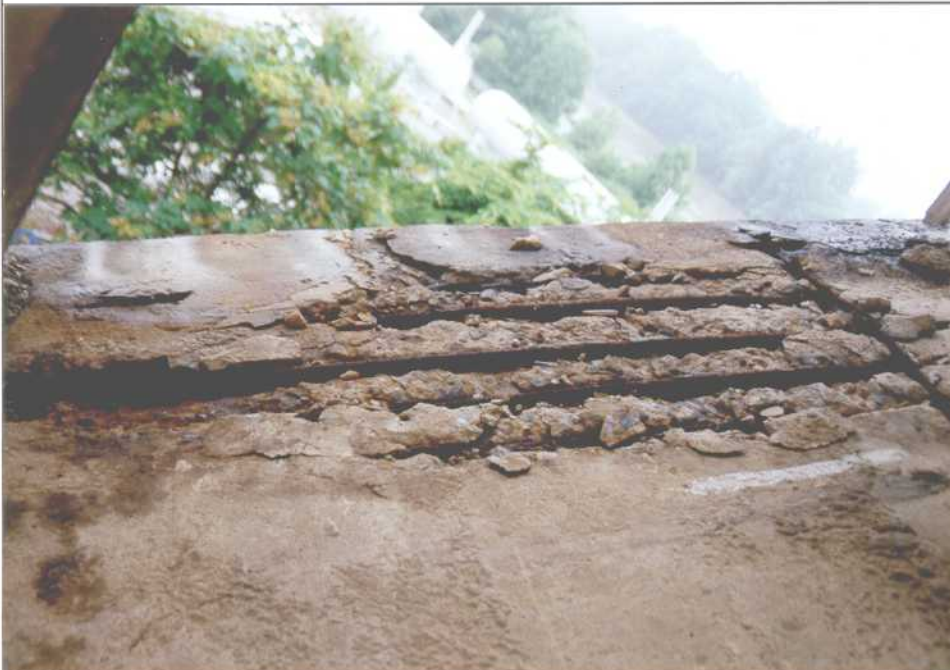
C216-2

**DOWNSTREAM ARCH, SPAN C - NOTE SPALLED CONCRETE WITH EXPOSED REINFORCING STEEL ON TOP OF ARCH.**

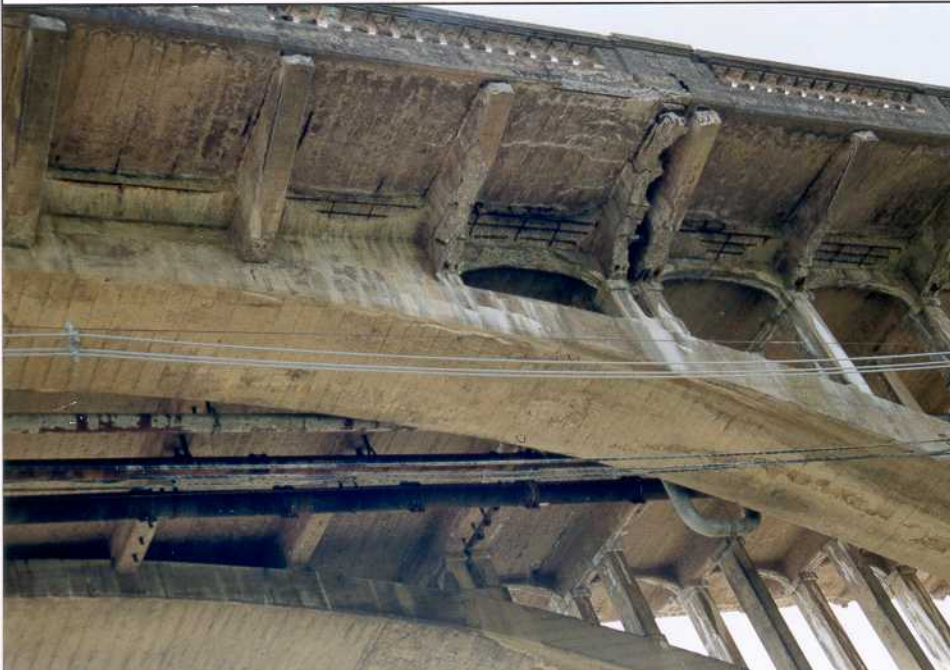
**A104-18**

**SEVERE DETERIORATION, DECK, FLOORBEAMS, COLUMNS, ARCH, SPAN D, UPSTREAM ARCH NEAR CROWN.**

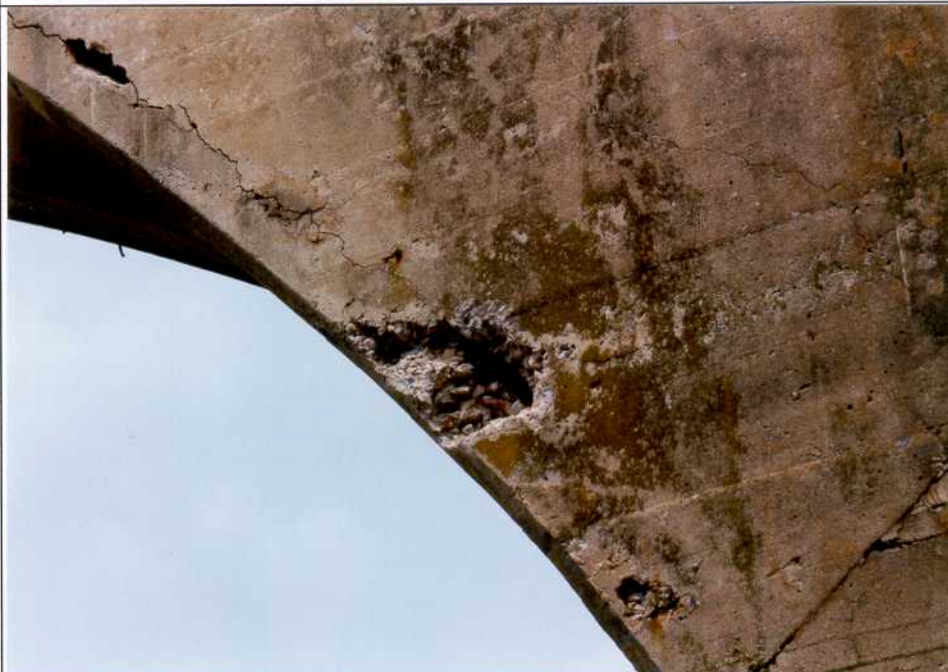
**C215-12**

**SPAN D, DOWNSTREAM SIDE NEAR PIER 4 - NOTE  
DETERIORATED CONCRETE ON SIDE OF ARCH.**

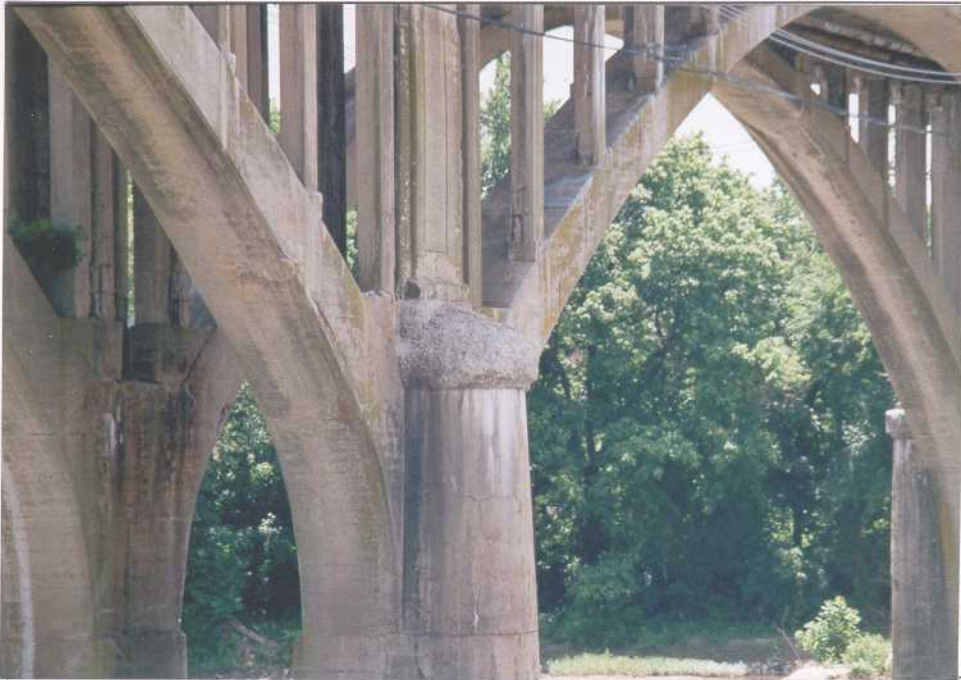
**A104-24**

**SEVERE CONCRETE SCALE, UPSTREAM END, PIER 6.**

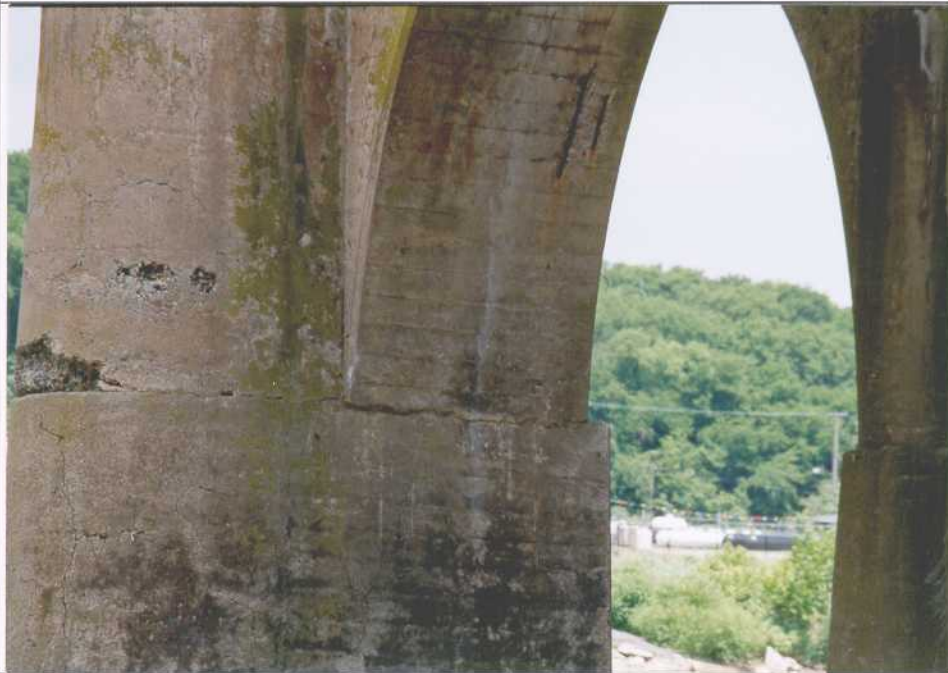
**A105-8**

**SEVERE HONEYCOMB, PIER 7, UPSTREAM SIDE.**

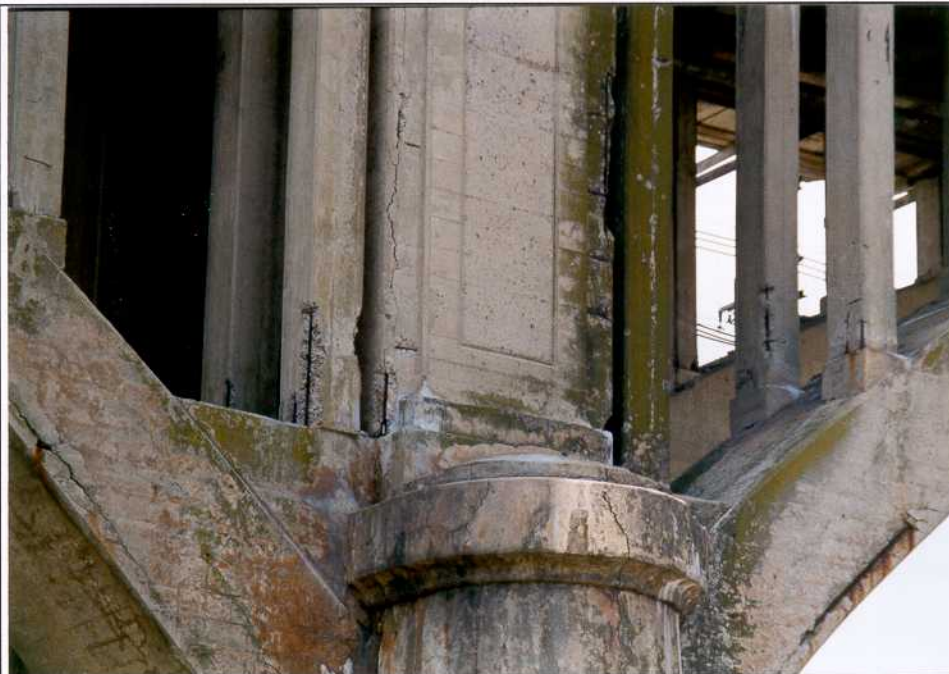
**A105-10**

**SEVERE DETERIORATION IN DOWNSTREAM ARCHES AT PIER 7.**

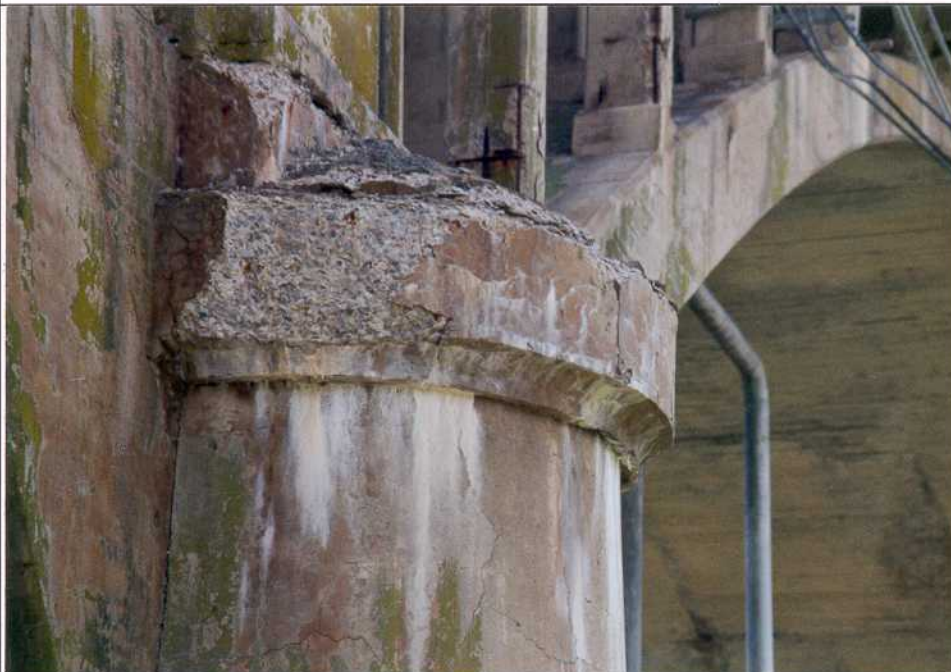
A105-4

**SEVERE SCALE, UPSTREAM END, PIER 8 CAP.**

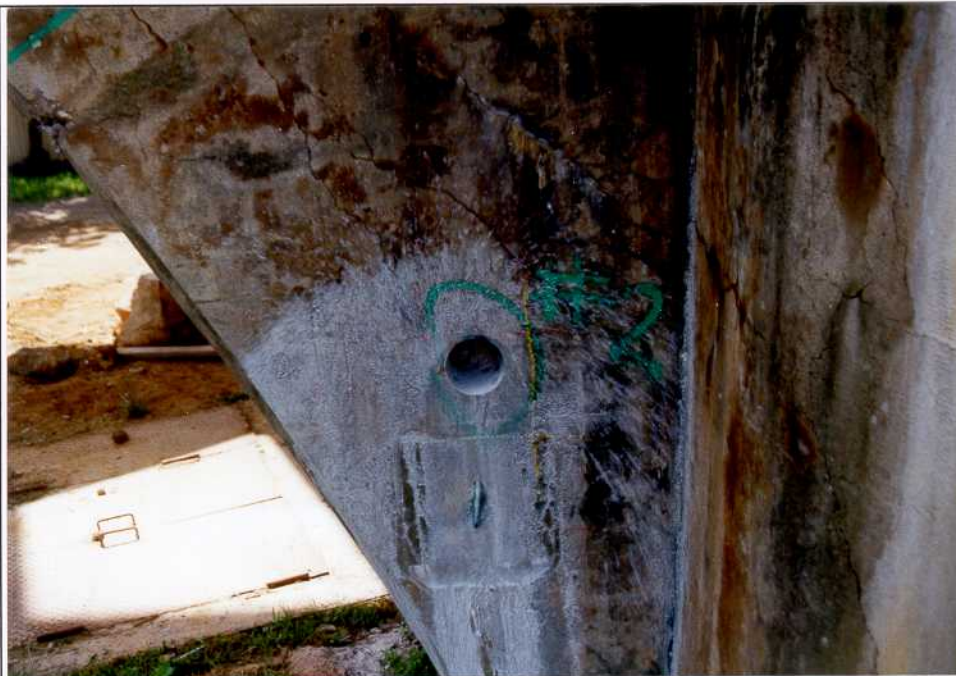
C216-21

UPSTREAM ARCH, SPAN B, WEST FACE OF ARCH, 3' ABOVE GROUND LINE, AT PIER 3 - NOTE CORE HOLE #2.

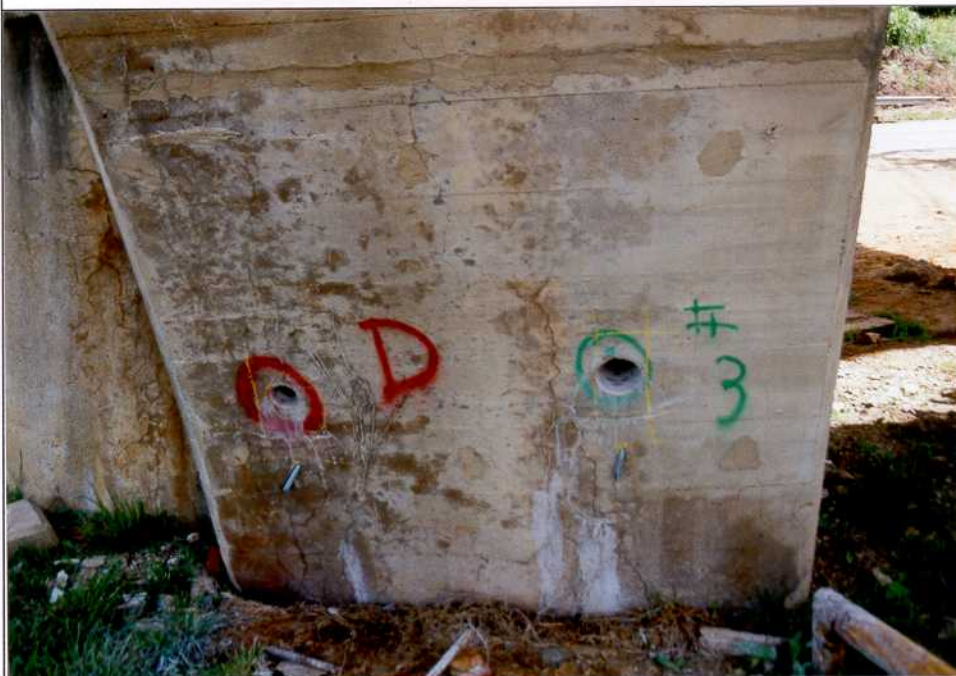
C216-22

UPSTREAM ARCH, SPAN C, SOUTH FACE OF ARCH, 3' ABOVE GROUND LINE, AT PIER 3 - NOTE CORE HOLES D AND #3.

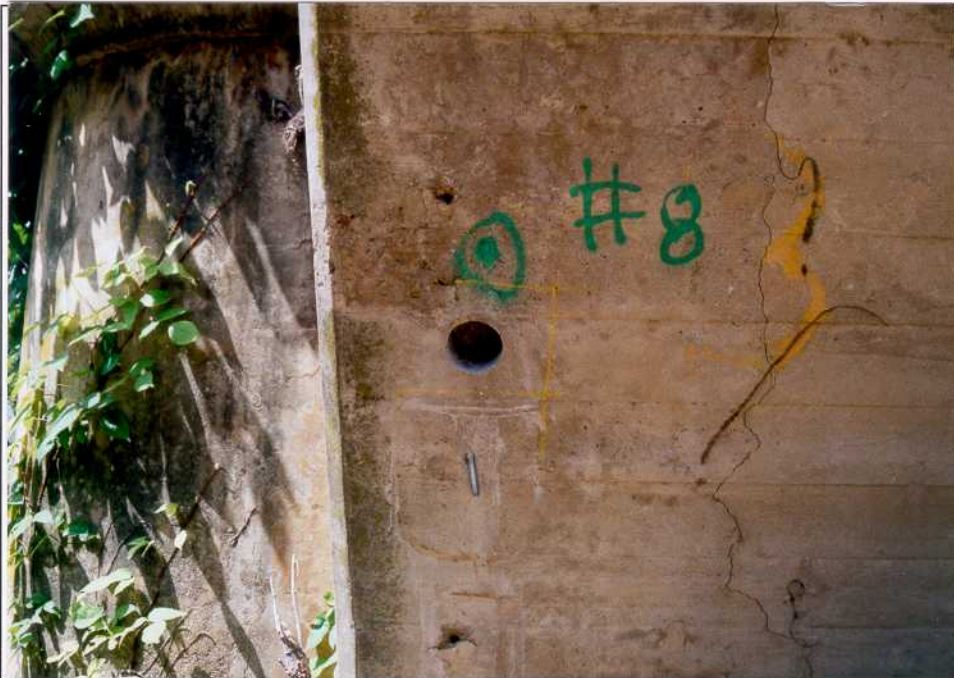
C216-24

**DOWNSTREAM ARCH, SPAN B, NORTH FACE OF ARCH, 4' ABOVE GROUND LINE, AT PIER 3 - NOTE CORE HOLE #8.**

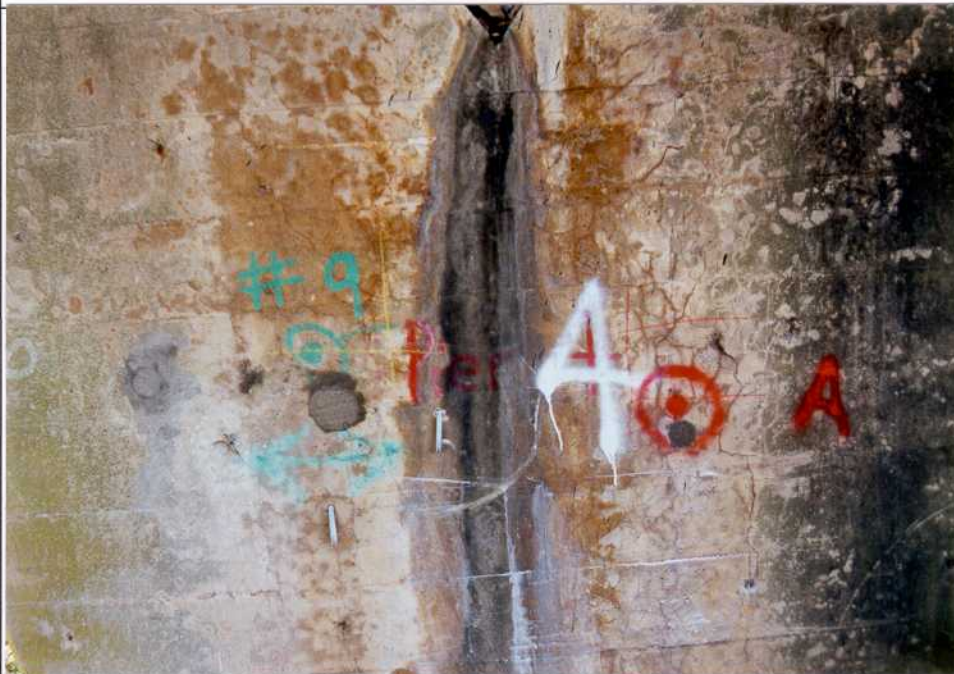
C217-4

**DOWNSTREAM ARCH, SPANS C & D, PIER 4, WEST FACE - NOTE CORE HOLES #9 AND A LOCATED 4' ABOVE GROUND LINE.**

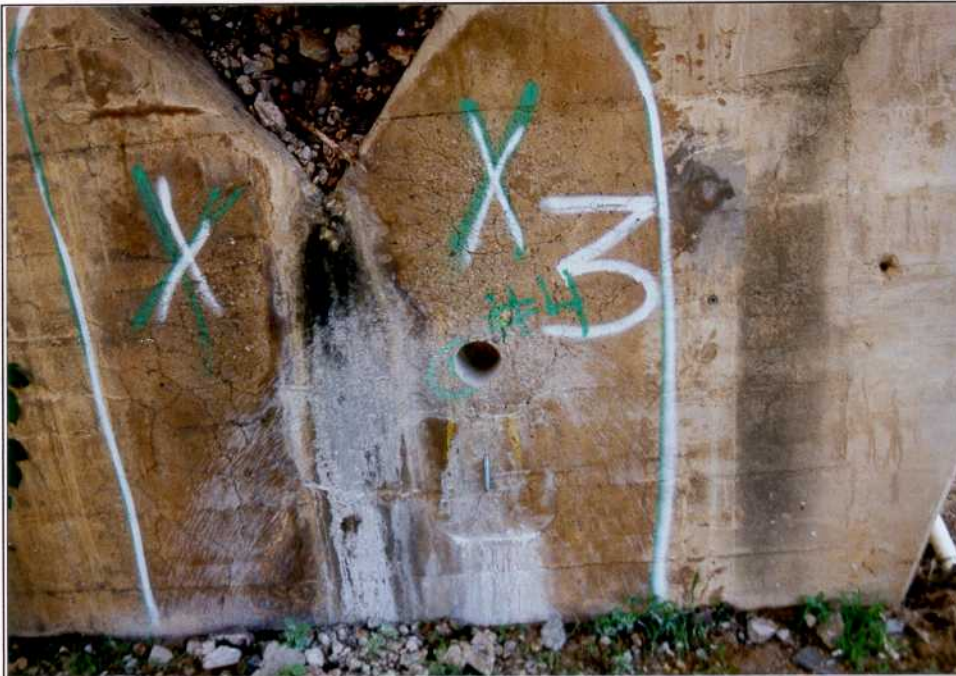
C216-23

**DOWNSTREAM ARCH, SPAN C, WEST FACE OF ARCH, 3' ABOVE GROUND LINE, AT PIER 3 - NOTE CORE HOLE #4.**

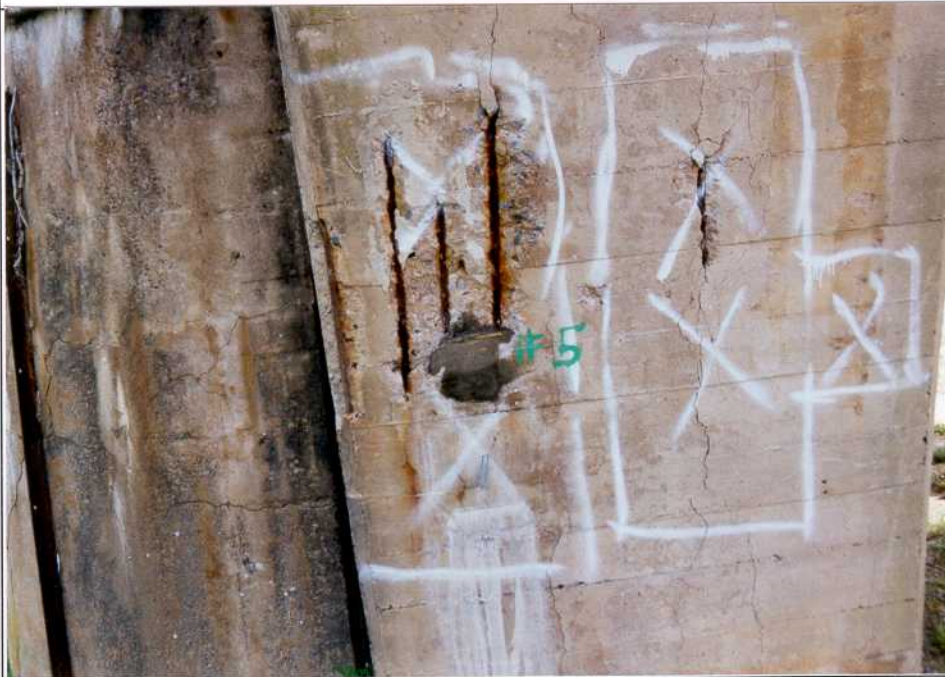
C217-6

**UPSTREAM ARCH, SPAN D AT PIER 4, SOUTH FACE - NOTE CORE HOLE #5 LOCATED 5' ABOVE GROUND LINE.**

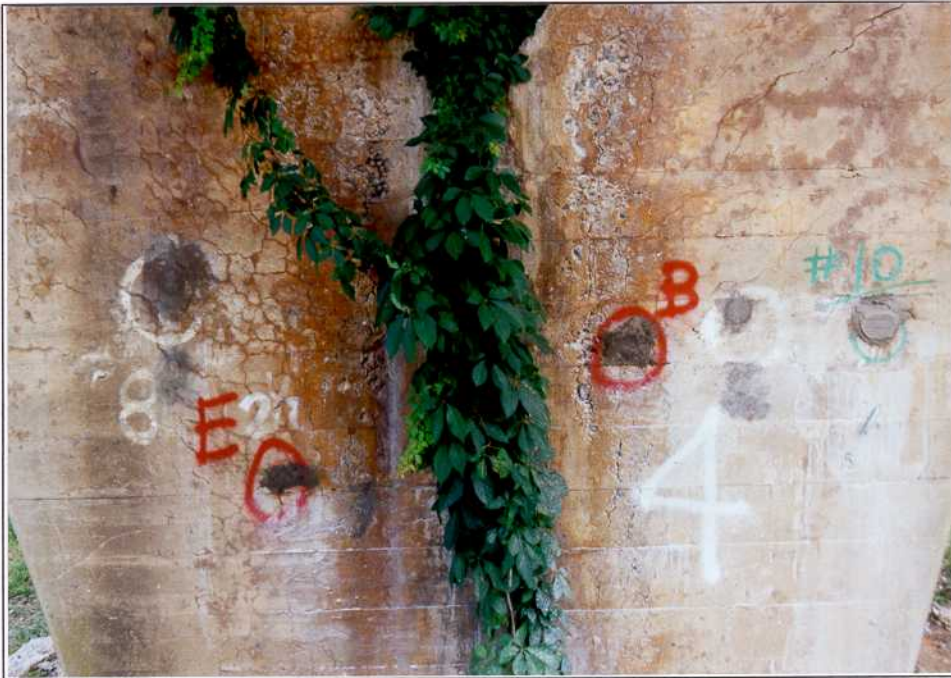
C217-5

UPSTREAM ARCH, SPANS C & D AT PIER 4, EAST FACE -  
NOTE CORE HOLES B, E AND #10 LOCATED 3'-4' ABOVE  
GROUND LINE.

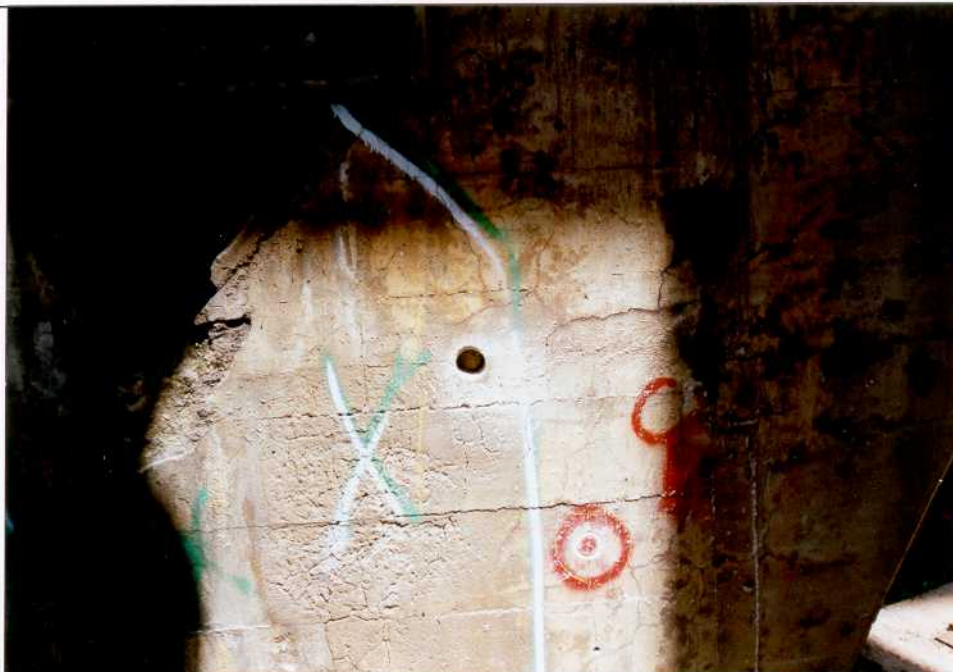
C216-20

UPSTREAM ARCH, SPAN B, EAST FACE OF ARCH, 3' ABOVE  
GROUND LINE, AT PIER 3 - NOTE CORE HOLE C.

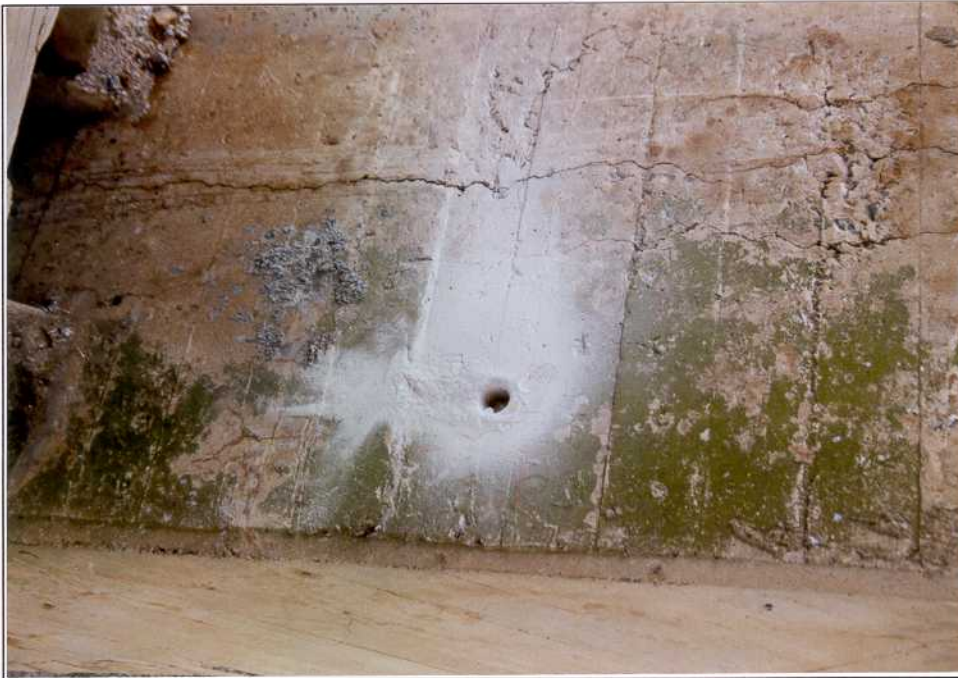
C216-9

SPAN C, NEAR PIER 4, UPSTREAM SIDE - 2" CORE G TAKEN ON TOP OF ARCH.

- Core G: No alkali silica reaction products observed at the time of this evaluation.
- Core H: Significant presence of gel formation in this sample. Multiple aggregate particles reacted and gel formation was observed at the periphery of aggregate particles and pockets in the paste. The occurrence of gel formation was noted throughout the entire sample. Expansion from gel formation caused multiple cracks in aggregate particles and micro fractures were noted in the paste.

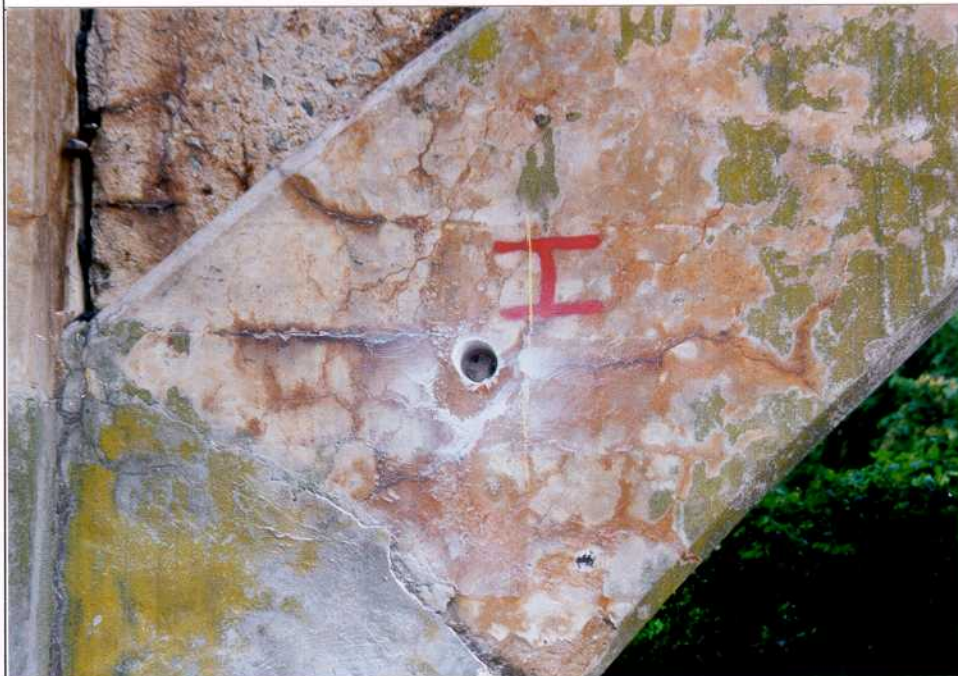
C216-10

SPAN I, UPSTREAM SIDE, WEST FACE OF ARCH, 1' ABOVE SPRING LINE - NOTE CORE HOLE I.

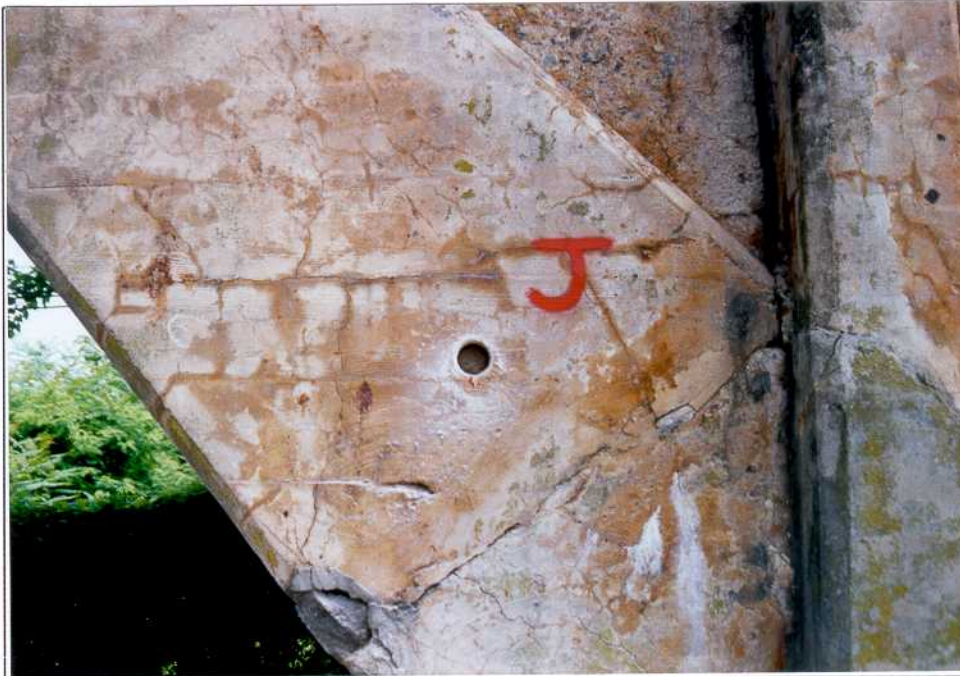
C216-11

SPAN H, UPSTREAM SIDE, WEST FACE OF ARCH, 0.5' ABOVE  
SPRING LINE - NOTE CORE HOLE J.
